Final

Descent

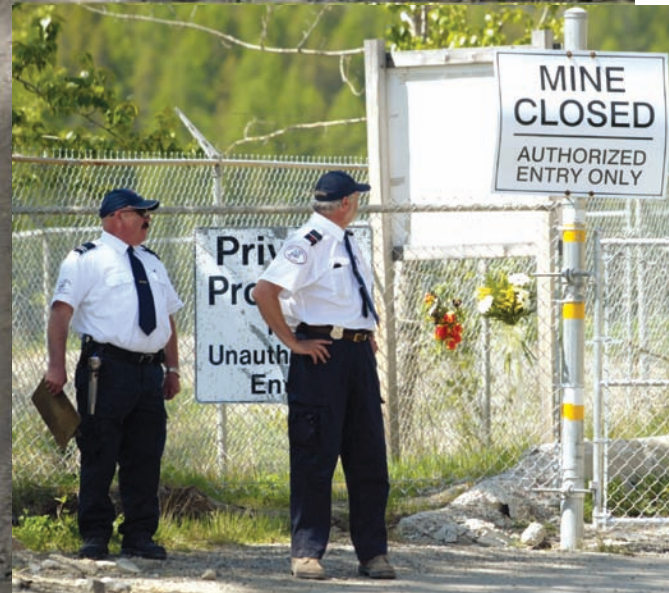
Above: Aerial view of the small shed at the Sullivan Mine, where four people died in an oxygen-deficient sump. Inset: Guards stand at the locked gates of the decommissioned mine.
